Appendix B
Photograph Log and Photographs

Super Salvage, Inc.
Industrial Stormwater Inspection Report

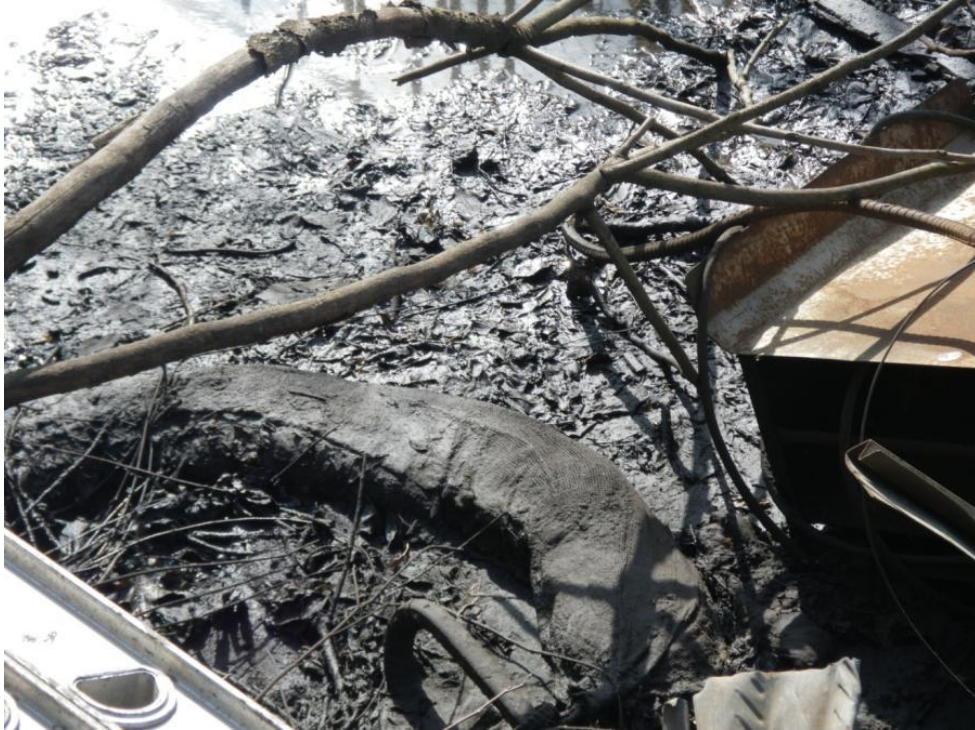
Photograph 39. Saturated absorbent sock at the northern end of the large runoff collection pond.

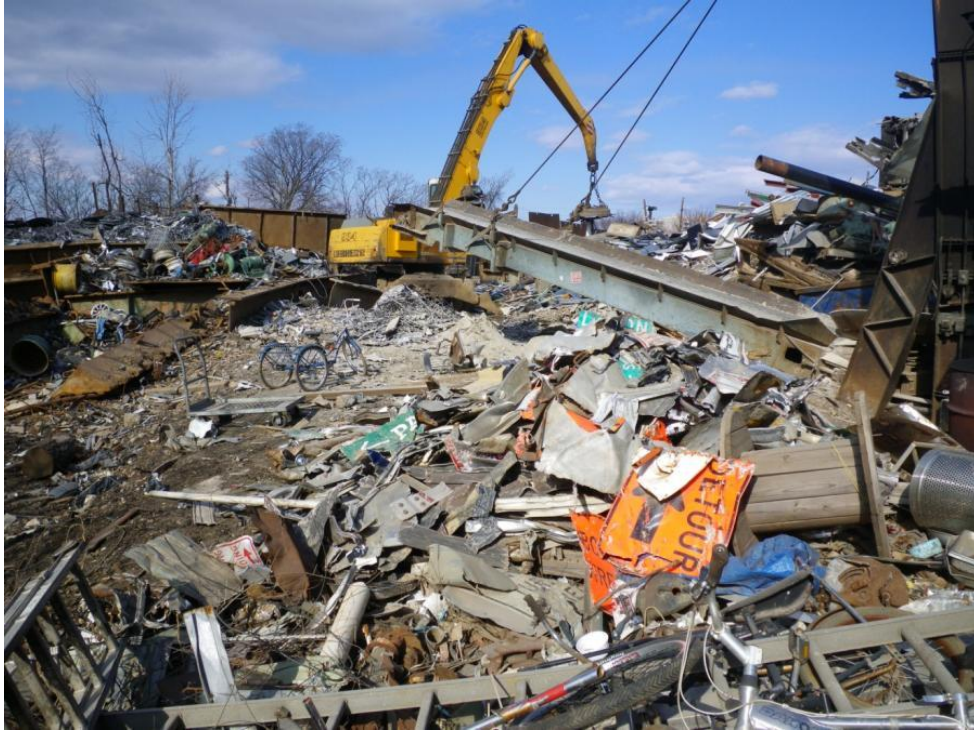
Photograph 41. Overall view of the facility from the northern end of the large runoff collection pond.

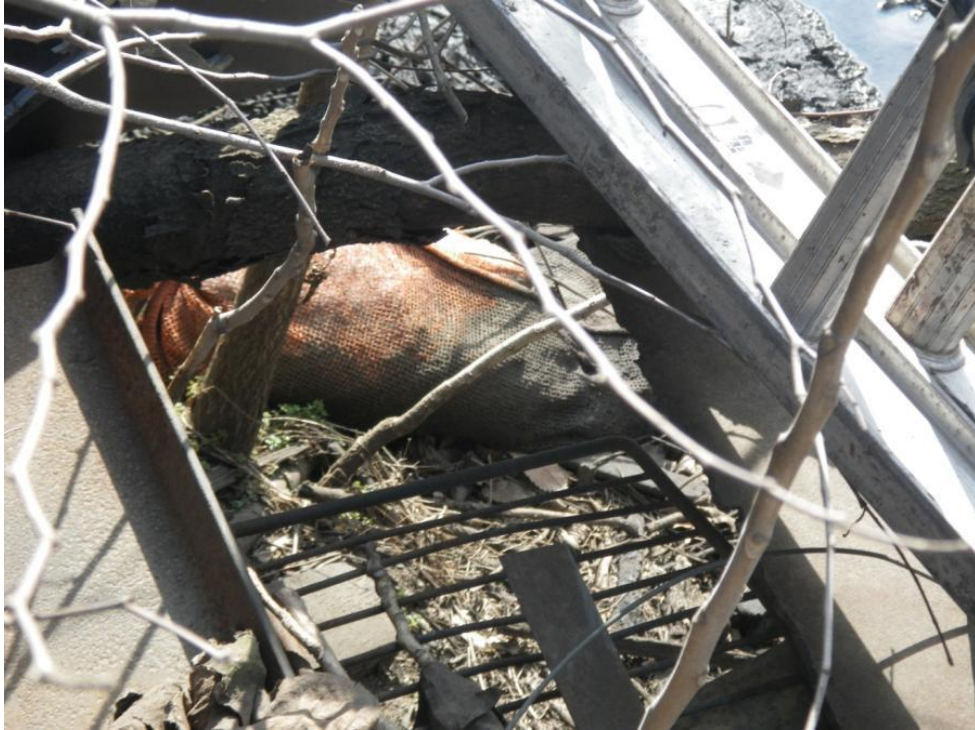
Photograph 43. Close-up view of the absorbent sock with orange indicating its original color at the northern end of the large runoff collection pond.

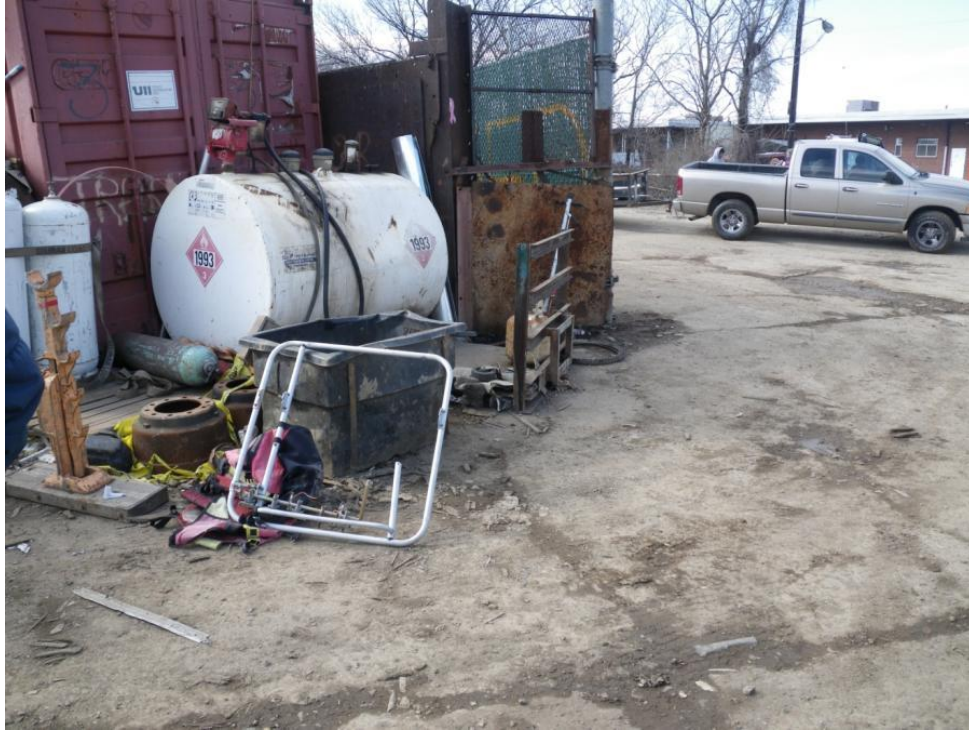
Photograph 53. 500-gallon diesel tank stored by oxygen tanks near Entrance 2.

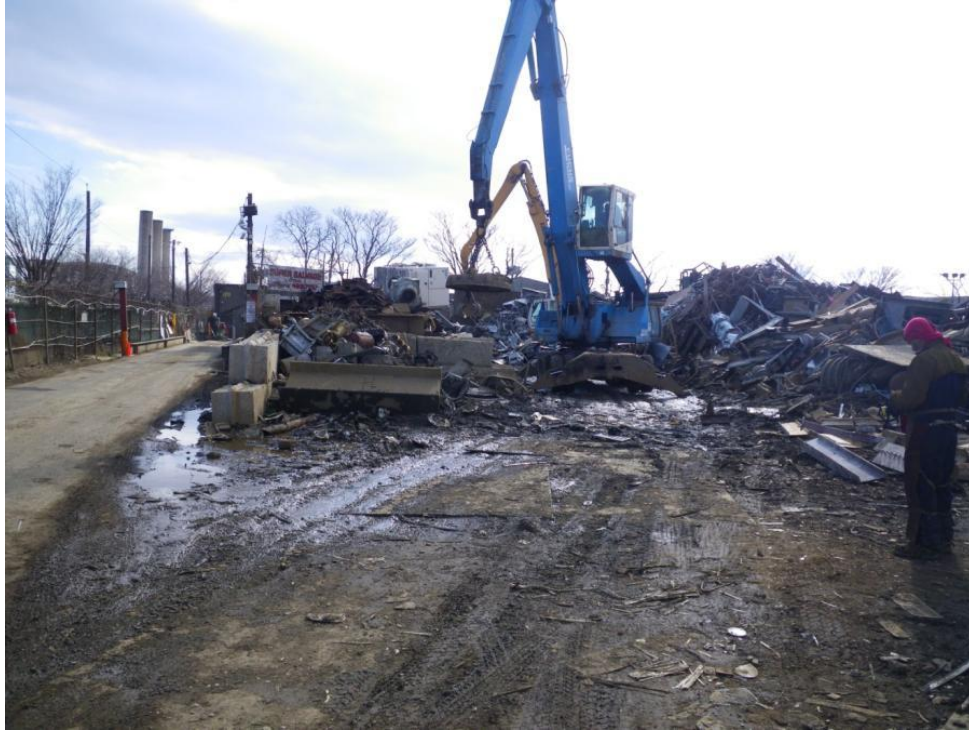
Photograph 55. View of the weigh station and magnet separator near pooling water.

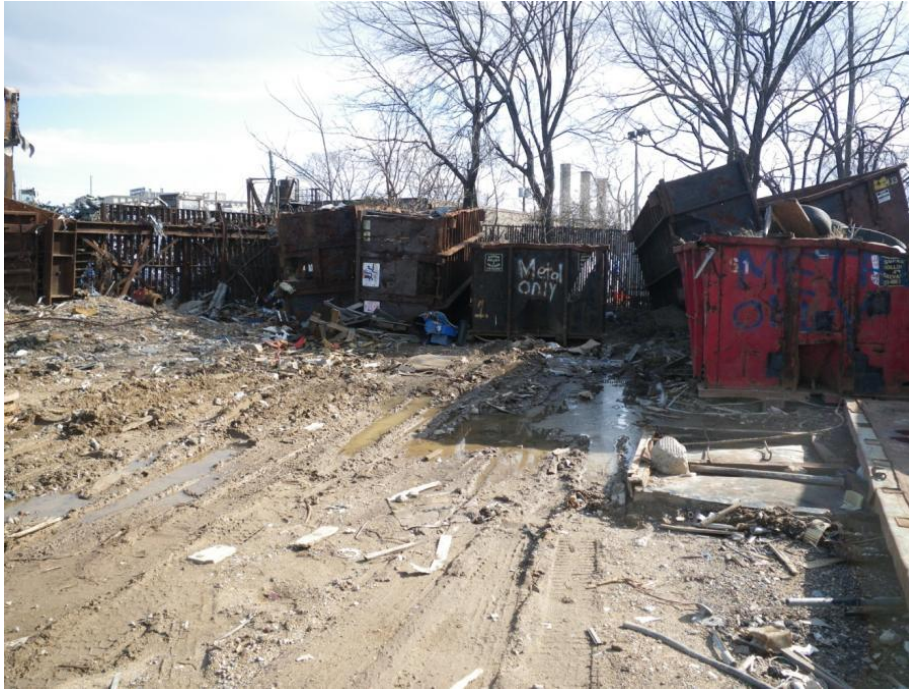
Photograph 63. Super Salvage dumpsters containing scrap stored on DC property near the Super Salvage property line. Note liquid draining from the dumpsters.

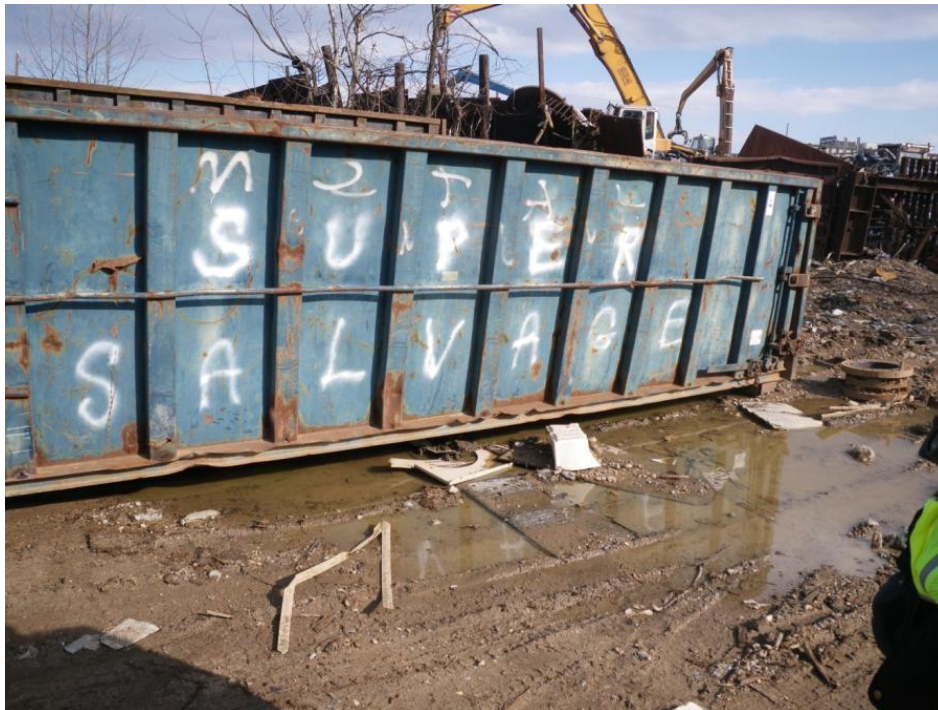
Photograph 64. Super Salvage metal dumpsters and pooled water. Dumpsters are located on DC property adjacent to the Super Salvage fence line.

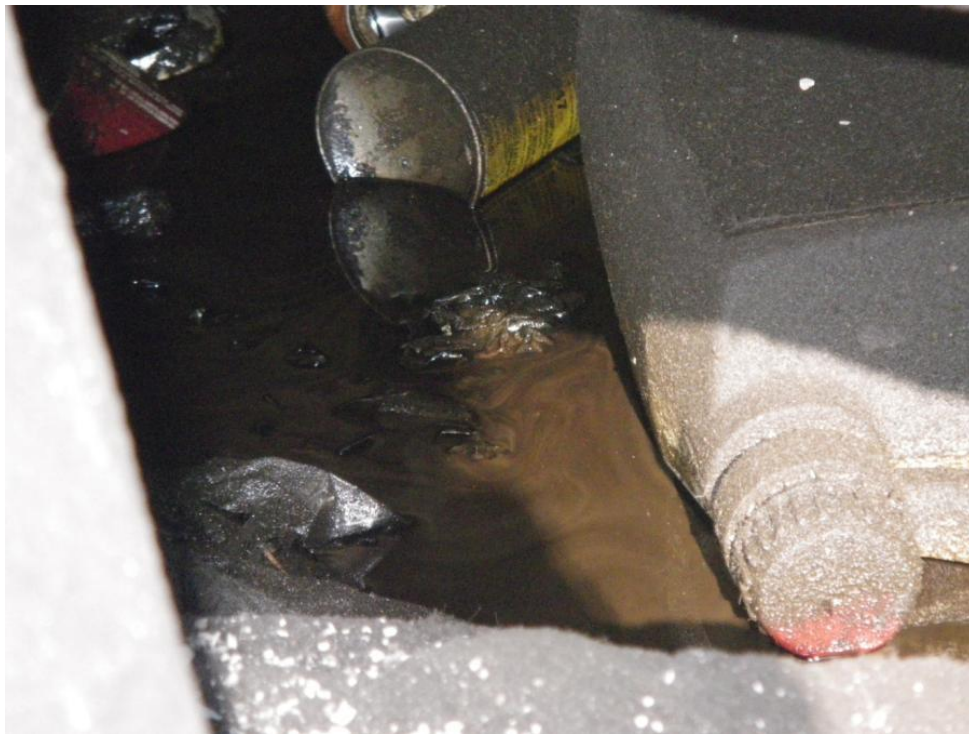
Photograph 68. Close-up view of what appears to be oil pooling under tanks.

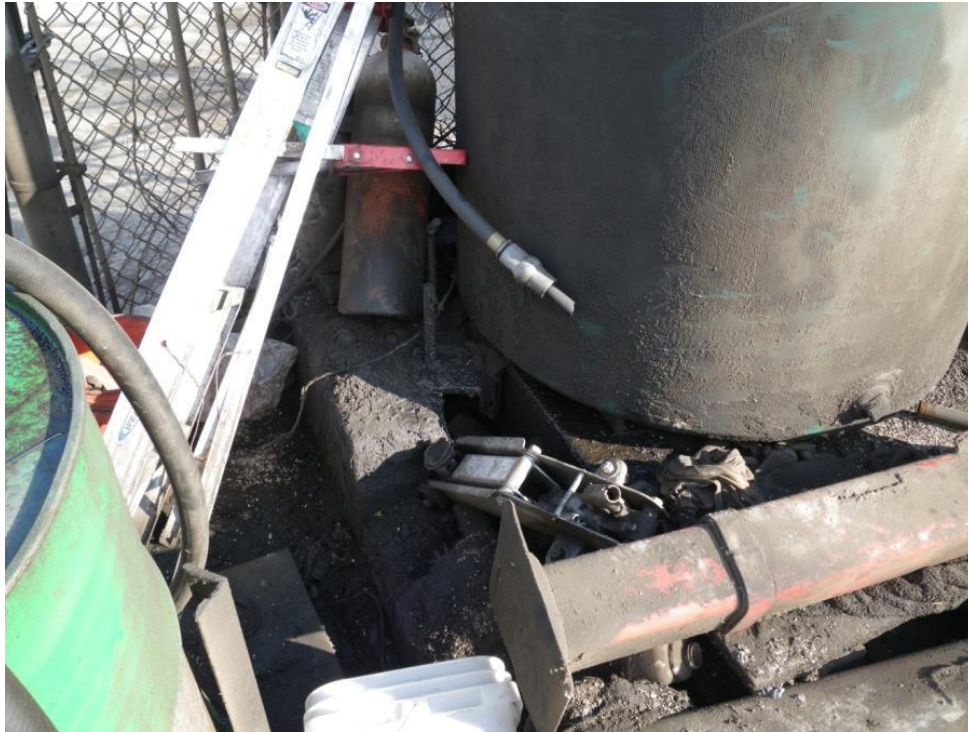
Photograph 69. **Wide view of tanks near Entrance 1.**

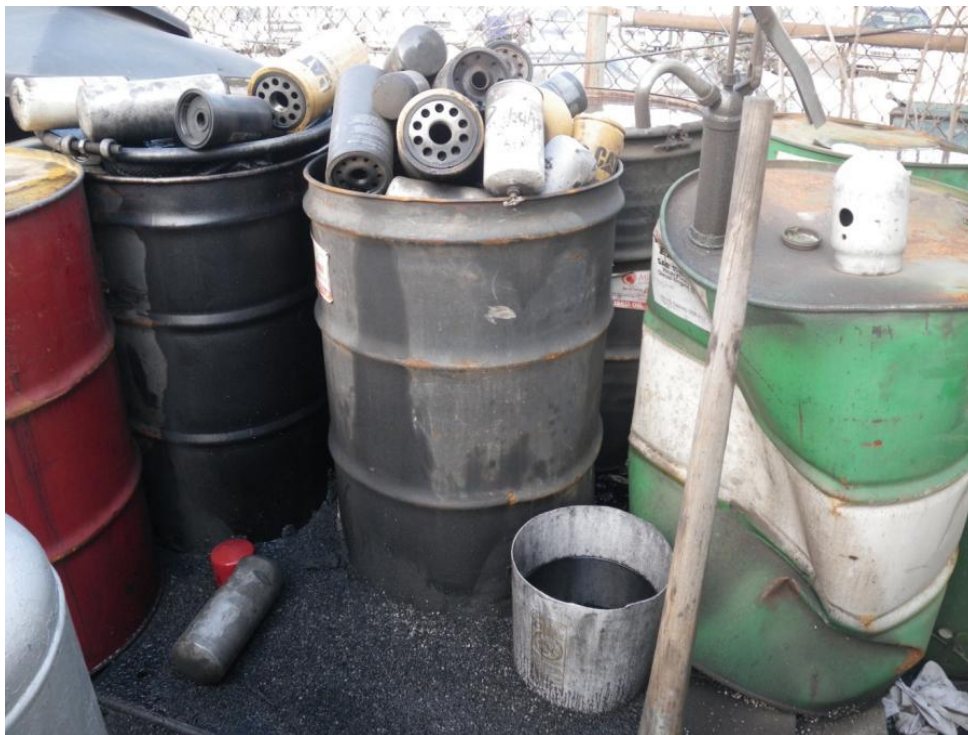
Photograph 70. **View of open buckets and storage drums containing used oil filters on top of secondary containment covered in absorbent material.**

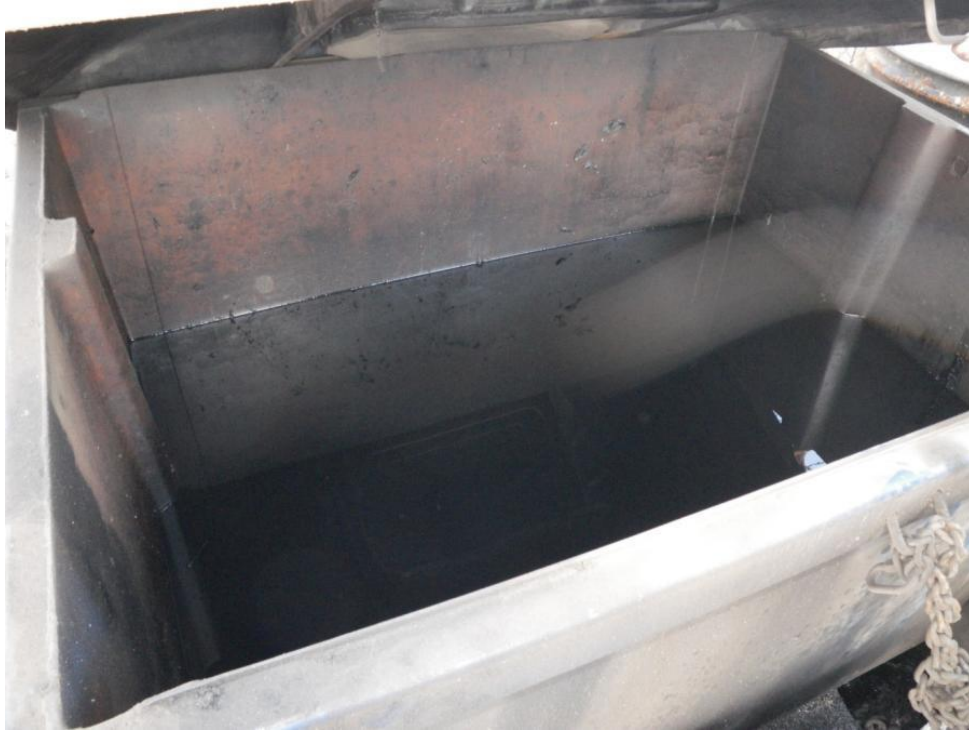
Photograph 71. Plastic container/dumpster of what appears to be waste oil adjacent to the property boundary.

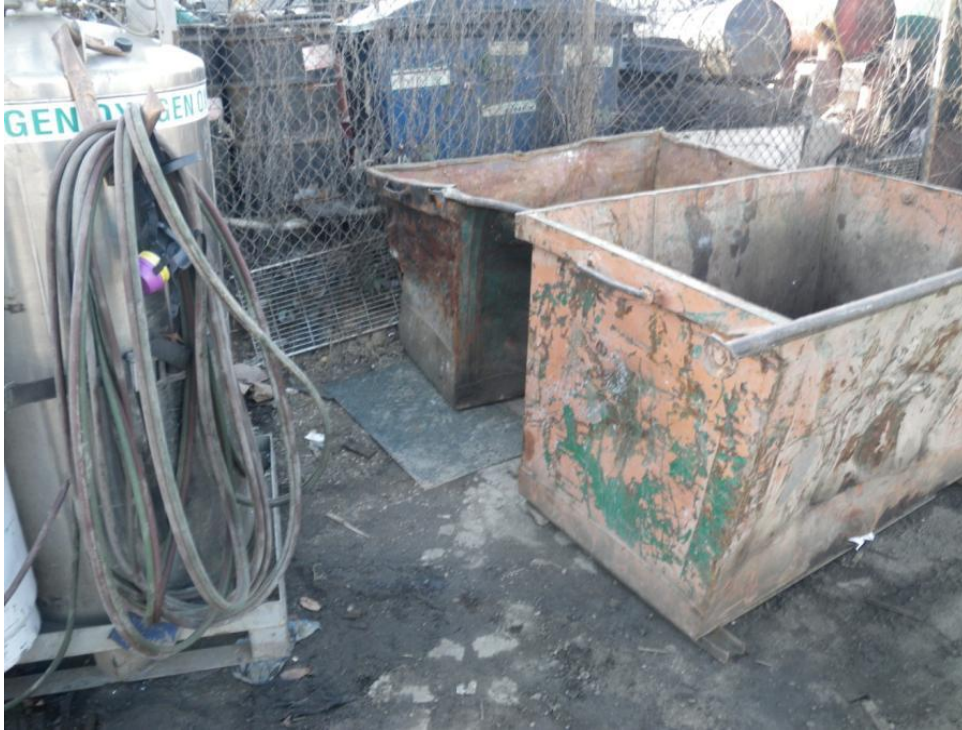
Photograph 77. **Alternate view of items stored outside of the perimeter fence.**

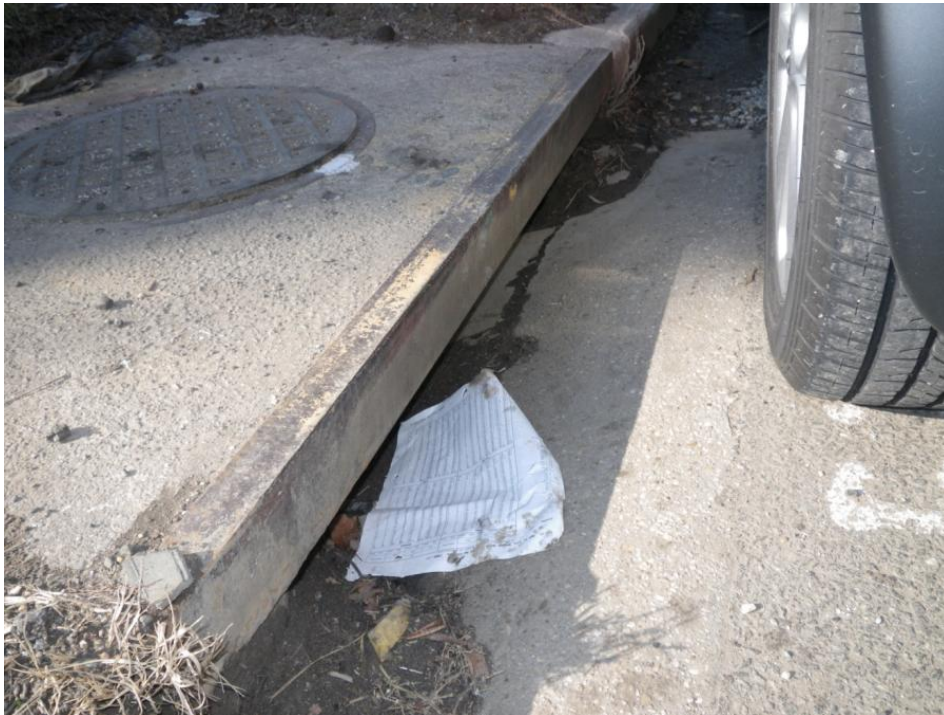
Photograph 80. View of storm drain closest to site near the corner of First Street SW
and S Street SW.

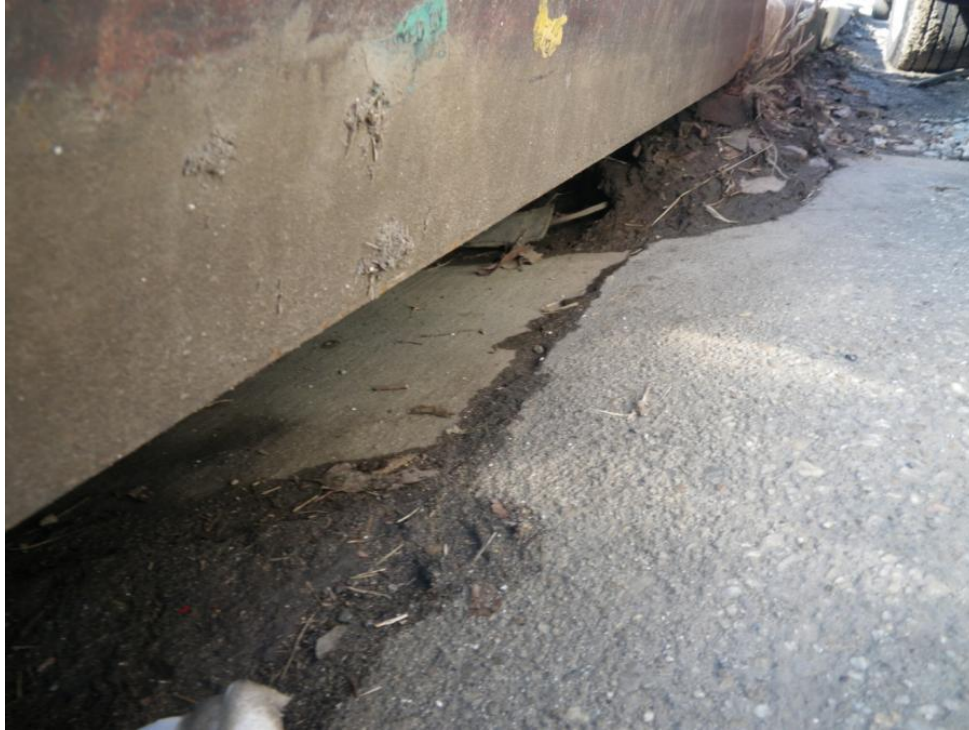
Photograph 81. Close-up view of the storm drain with sediment entering from street.
Storm drain is near the corner of First Street SW and S Street SW.
